SERVICE INSTRUCTIONS

No. 1117
ATA Code 24-50

SUBJECT: ELECTRICAL POWER - REPLACEMENT OF LOAD METER 15 AMP FUSES AND SPARES WITH 5 AMP FUSES AND SPARES

EFFECTIVITY: BEEHCRAFT Duchess 76, serials ME-183 through ME-237 and ME-239.

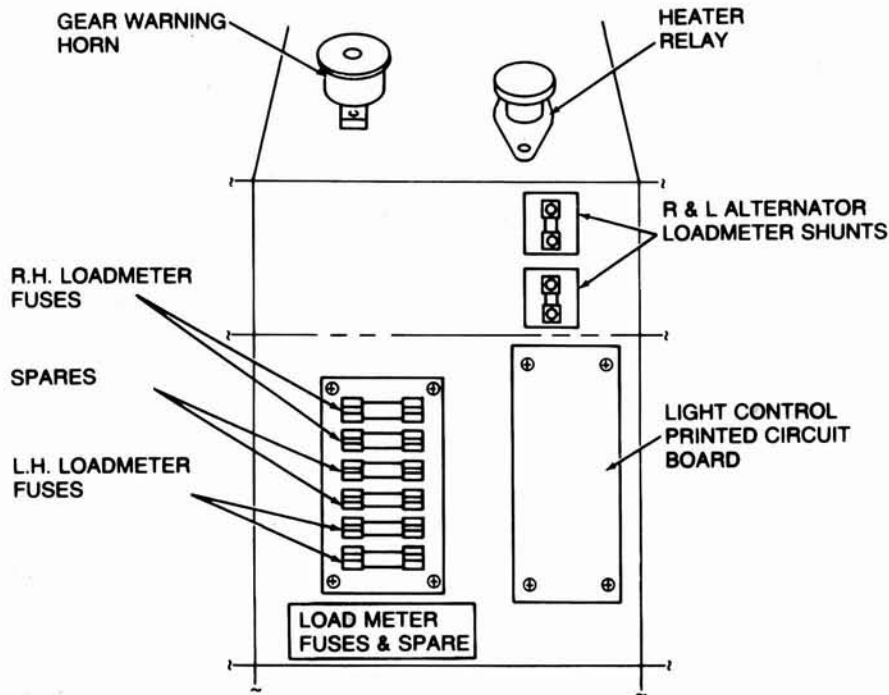
Figure 1.

REASON: To provide improved load meter system protection.

2. Remove and discard the P/N MDA15 load meter fuses and spares from the load meter panel located on the RH forward side of the lower center panel console. Reinstall the new P/N MDA5 fuses and spares as shown in figure 1.
