No. 1122
ATA Code 76-10

SUBJECT: ENGINE CONTROLS - INSTALLATION OF IMPROVED FEATHERING STOP SPRING

EFFECTIVITY: BEEHCRAFT Duchess 76, serials ME-1 through ME-299.

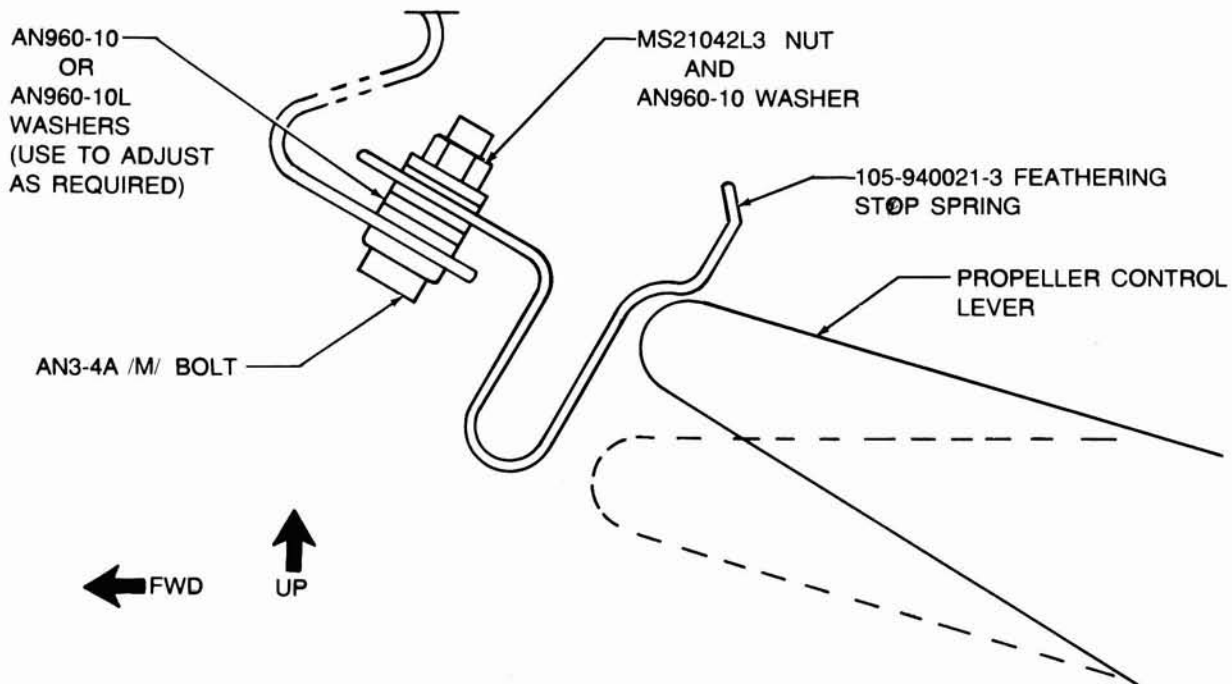
REASON: To reduce the possibility of the propeller control levers becoming locked in the FEATHER position.

4. Remove the P/N 105-940021-1 feathering stop spring and install the new P/N 105-940021-3 stop spring.

5. Adjust the new feathering stop spring as necessary to obtain proper detent action with the propeller control levers (see illustration). The elongated holes in the feathering stop spring allow adjustment forward and aft for proper detent action.

6. To check for proper vertical adjustment, refer to the Pilot's Operating Handbook and FAA Approved Airplane Flight Manual starting procedures and ground run both engines. Pull the propeller control levers back until they contact the feather stop detent. Do not pull the propeller levers into the feather position. Slowly move the throttles forward until the rpm stabilizes. The rpm reading should be 2000 ± 25 rpm. If adjustment is necessary, add or remove washers as necessary under the feathering stop spring (see illustration).
