No. 1124  
ATA Code 27-15

**SUBJECT:** CONTROL COLUMN - INSTALLATION OF A FOOT GUARD

**EFFECTIVITY:** BEEHCRAFT Skipper 77, serials WA-2 through WA-80.

**Service Instructions No. 1124**

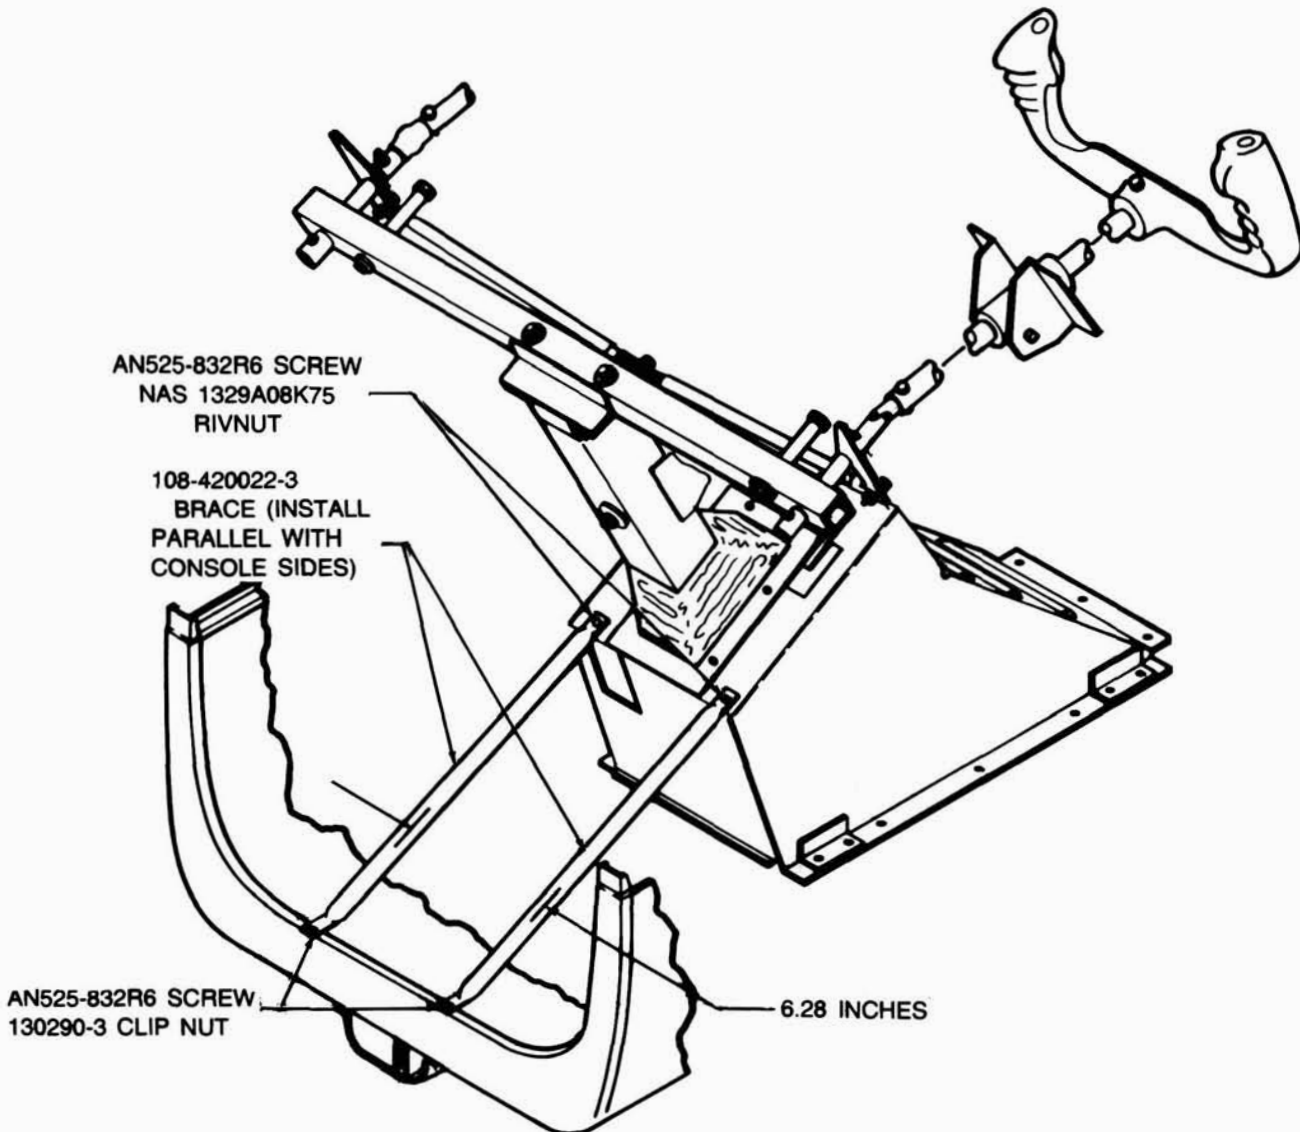
**REASON:** To reduce the possibility of the pilot's or copilot's foot being caught forward of the control column floor console.

1. Remove the cockpit seats as described in the Maintenance Manual.
2. Locate a P/N 108-420022-3 brace between one top forward corner of the control console and the flange on the firewall as shown in the illustration.

3. Using the holes in the brace as a guide, mark the positions of the holes to be drilled in the console and the flange.
4. In the console, drill a No. 2 (.221 inch diameter) hole at the location marked in step 3, notch the edge of the hole to fit the rivnut key, and install a P/N NAS1329A08K75 rivnut.
5. In the firewall flange, drill a No. 19 (.166 inch diameter) hole at the location marked in step 3 and install a P/N 130290-3 clipnut over the firewall flange with the nut on the lower side of the flange.
6. Locate the brace over the rivnut and clipnut and install the brace with P/N AN525-832R6 screws.
7. Repeat steps 1 through 6 on the opposite side of the console.
8. Replace the cockpit seats.
