# CLASS I SERVICE INSTRUCTIONS

No. 1135  
ATA Code 27-30

**SUBJECT:** FLIGHT CONTROLS - REPLACEMENT OF THE ELEVATOR CONTROL ARM BUSHINGS

**EFFECTIVITY:** BEECHCRAFT Skipper 77, serials WA-1 through WA-59.

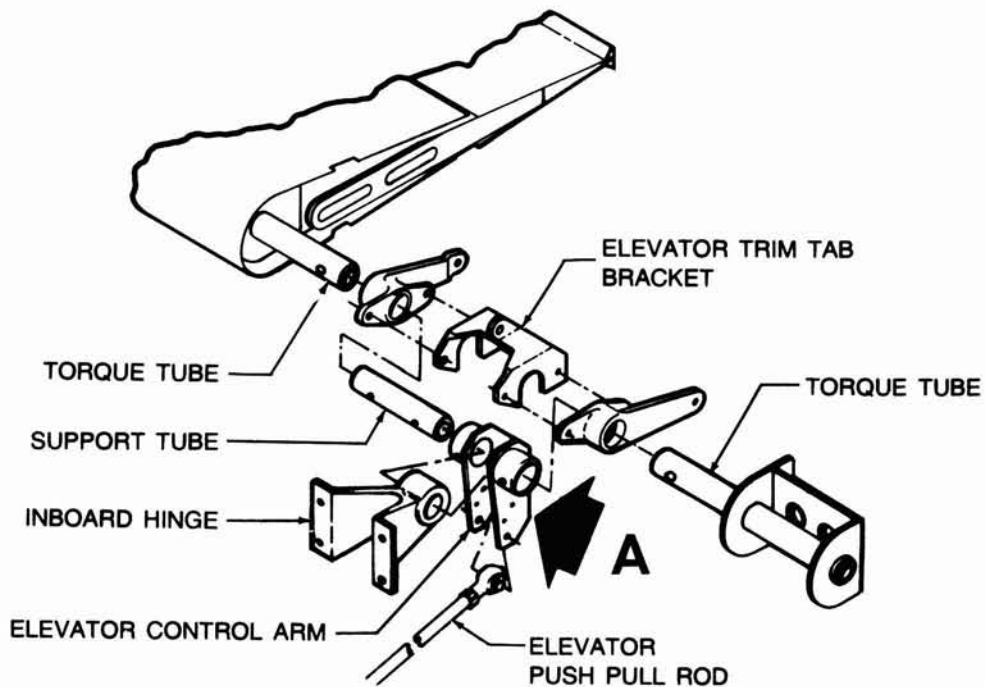
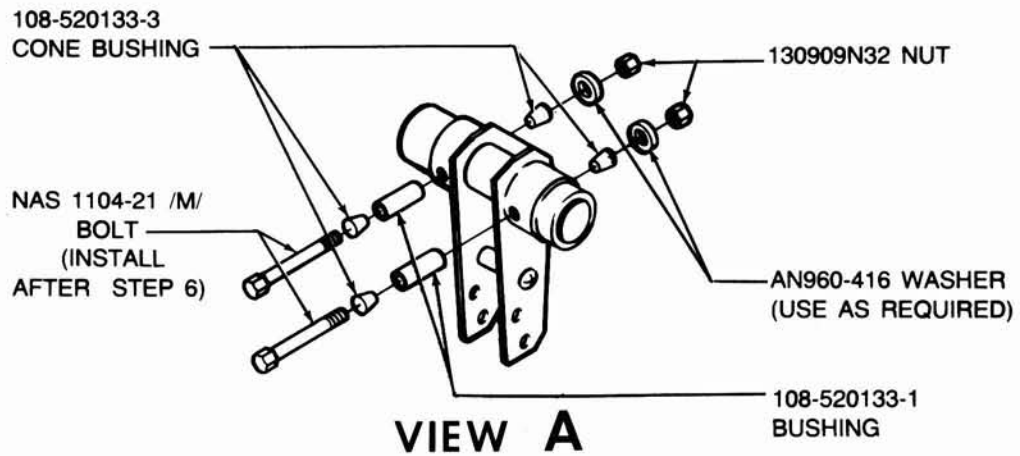
**REASON:** To reduce the possibility of free play in the elevator control arm assembly.

1. Remove the aft horizontal stabilizer fairing.
2. Remove and discard the two bolts, washers and nuts which connect the elevator torque tubes to the left and right side of the elevator control arm assembly.
3. Use the two new 108-520133-1 bushings to push out the original bushings which protected the bolts removed in Step 2. This will leave the new bushings in place without disturbing the alignment of the tubes and control arm assembly (see illustration, view A).
4. Insert the 108-520133-3 cone bushings and NAS1104-31 /M/ bolts in the 108-520133-1 bushings (see illustration, view A).

Lubrication of the mating surface between the cone and sleeve bushings will aid in allowing the cone bushings to slip into and expand the sleeve bushings without stripping or breaking the bolts and nuts being used to compress the parts.

5. Install a 130909N32 nut on each NAS1104-31 /M/ bolt, using AN960-416 washers as necessary to keep the nuts on the threaded portion of the shafts. Tighten the nuts, adding washers as necessary, until the cone bushings are pressed in place and all free play between the torque tubes, support tube and control arm has been eliminated.

7. Install two NAS1104-21 /M/ bolts in place of the bolts removed in Step 6, add AN960-416 washers as necessary, and install new 130909N32 nuts on the bolts. Torque the nuts to 75-100 inch-pounds.
8. Recheck the elevators to ensure that there is no free play present, and reinstall the aft horizontal stabilizer fairing.
