No. 1146
ATA Code 24-30

SUBJECT: ELECTRICAL POWER - INSTALLATION OF AN ALTERNATOR OUTPUT CURRENT LIMITER

EFFECTIVITY: BEECHCRAFT B19 Sport 150, serials MB-622 through MB-722 and MB-724 through MB-905; C23 Sundowner 180, serials M-1491 through M-2130; B24R and C24R Sierra 200, serials MC-191 through MC-642.

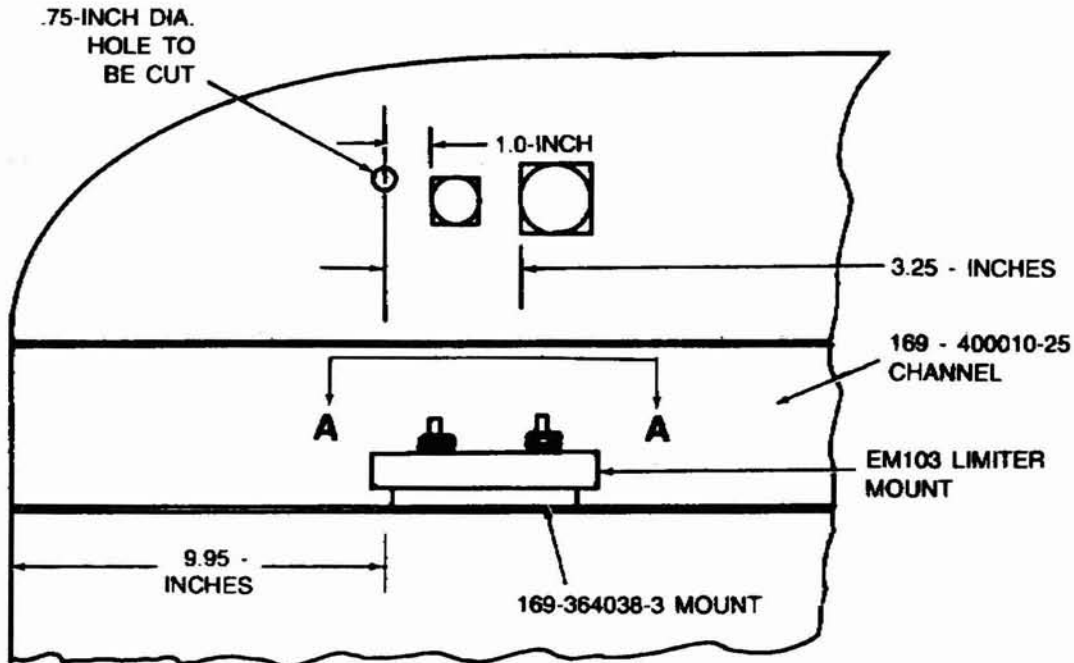
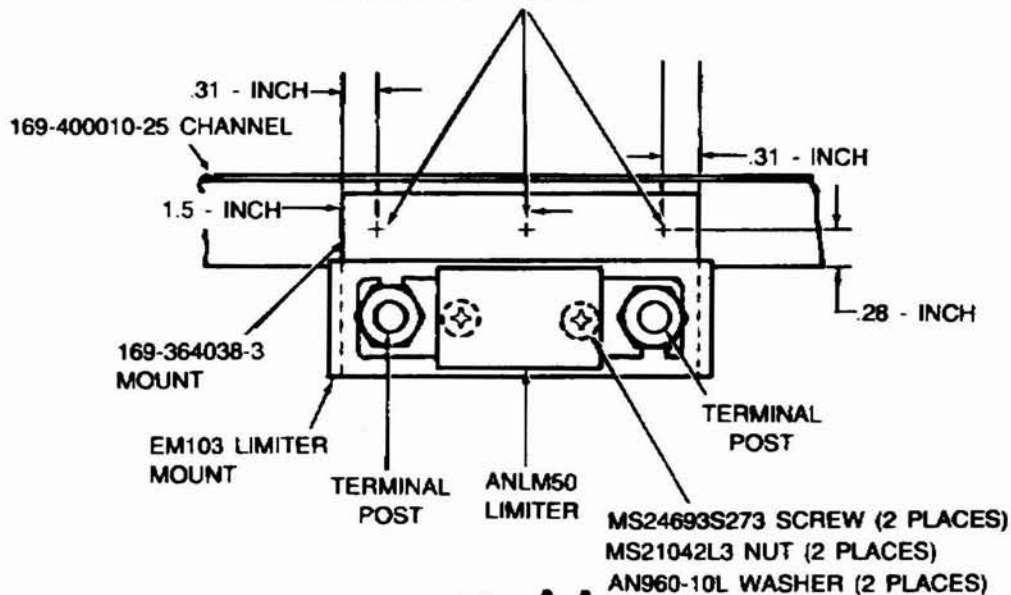
REASON: To provide a continuous maximum alternator output during peak demands.

DRILL THREE .128/.133-INCH DIAMETER HOLES AND INSTALL 169-364038-3 MOUNT USING THREE MS 20470AD4-5 RIVETS

4. Dead-end cap and stow the three inch portion of wire remaining in the firewall connector using one of the 324487 wire caps supplied with the kit.
5. Refer to Figure 1 and position the 169-364038-3 mount on the upper channel of the firewall as shown. Drill three .128/.133-inch diameter holes through the lower flange of the channel to match the position of the holes in the mount (see Figure 1, View A-A).

6. Attach the mount to the channel using three MS20470AD4-5 rivets.
7. Install the EM103 limiter mount on the channel mount installed in Step 6.
8. Locate and cut a .75-inch diameter hole in the firewall as shown in Figure 1.
