**SUBJECT:** FUSELAGE - INSPECTION OF THE SHOULDER HARNESS ATTACH BRACKET

**EFFECTIVITY:** BEECHCRAFT Skipper 77, serials WA-3 through WA-235, WA-237, WA-238, WA-240 through WA-254, WA-256, WA-258, WA-261 through WA-264, WA-266, WA-267 and WA-269.

**Service Instructions No. 1173, Rev. I**

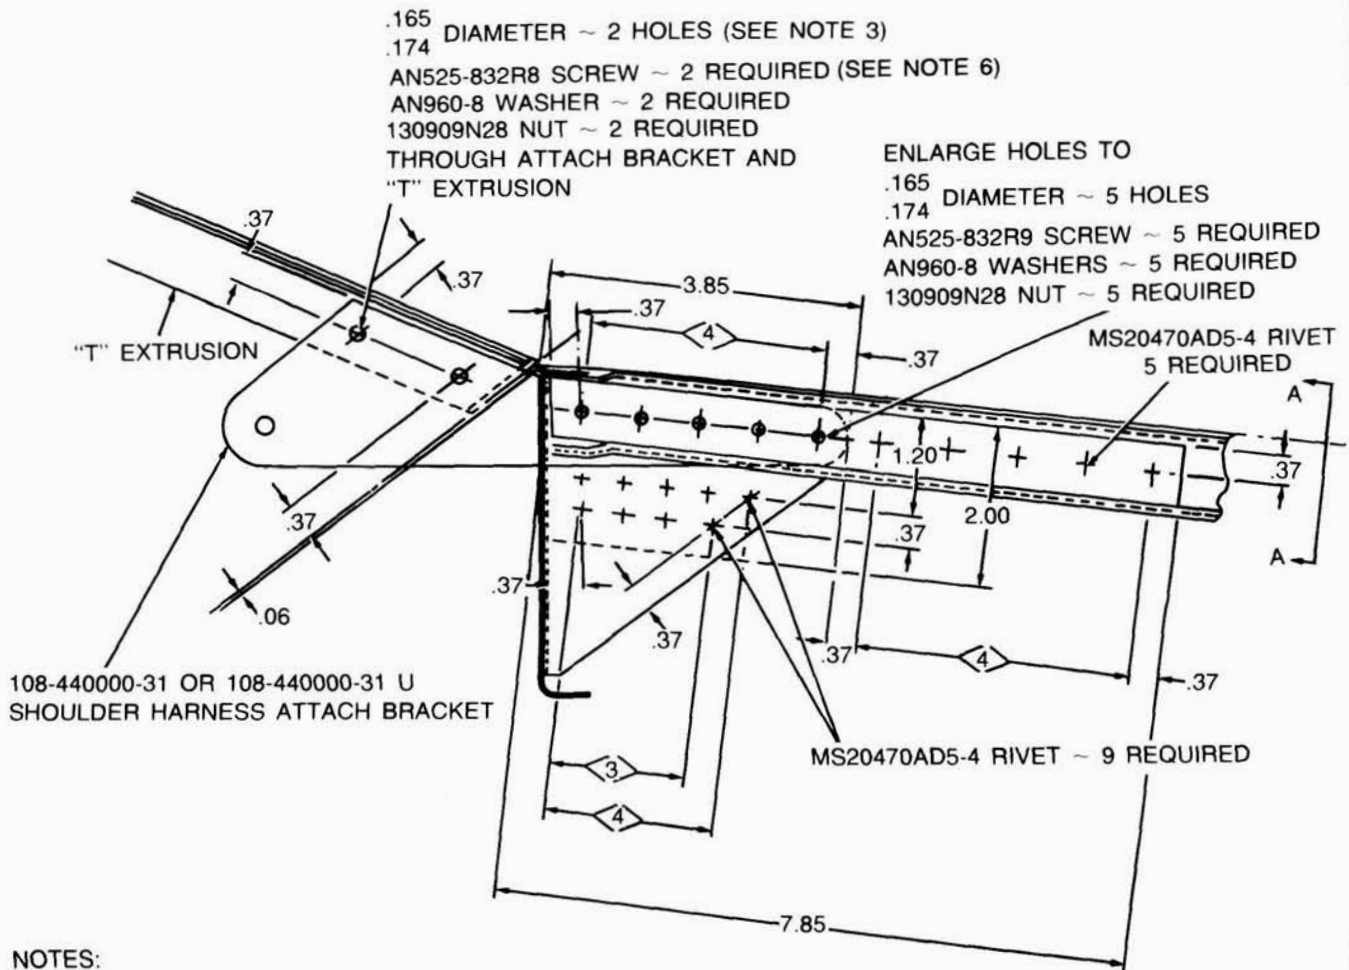
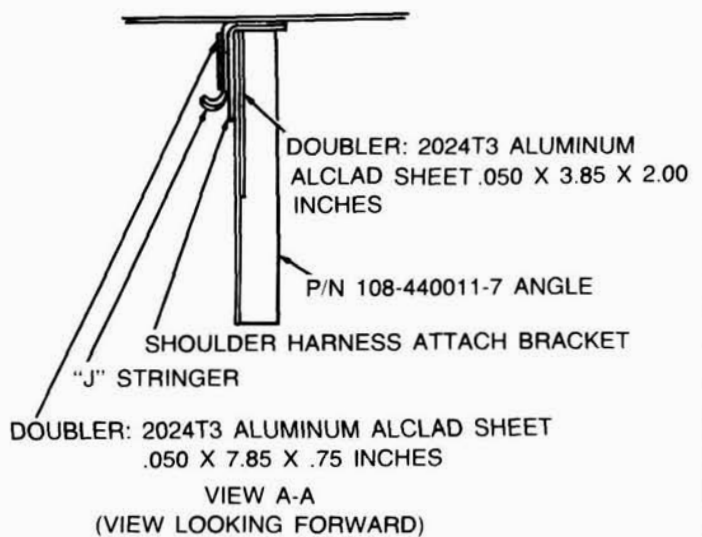
5. Remove the P/N 108-440000-31 shoulder harness attach bracket and inspect for proper edge distance as shown in the illustrations. Also inspect for elongated and/or double drilled holes in the bracket, "J" stringer and angle aft of the bulkhead. If proper edge distances exist on the P/N 108-440000-31 bracket and the holes are satisfactory, refer to Figure 1 for hole sizes and hardware for reinstallation of the bracket. Also refer to Notes 1, 2 and 3.

6. In the event elongated holes, double drilled holes or insufficient edge distances are encountered, refer to Figure 1 for fabrication of doublers, installation of the two doublers and installation of a new P/N 108-440000-31 U shoulder harness attach bracket. Refer to Notes 1 through 6 as they relate to various areas of the illustration.

1. SMOOTH ALL ROUGH EDGES AND REMOVE BURRS FROM ALL REWORKED AREAS. APPLY ZINC CHROMATE PRIMER TO ALL BARE METAL, INCLUDING HOLES, PRIOR TO ASSEMBLY.
2. ALL DIMENSIONS ARE IN INCHES
3. IF THREE RIVETS WERE ORIGINALLY INSTALLED IN THE SHOULDER HARNESS ATTACH BRACKET FORWARD OF THE BULKHEAD, USE THE FORE AND AFT HOLES FOR THE SCREWS
4. MAKE BOTH DOUBLERS (IF REQUIRED) FROM THE .050 x 2 x 12 2024T3 ALUMINUM ALCLAD SHEET SPECIFIED IN THE MATERIAL SECTION. TRIM THE FORWARD AND TOP EDGES OF BOTH DOUBLERS AS REQUIRED TO ASSURE PROPER FIT.
5.  $\diamond$  DENOTES APPROX. EQUAL SPACES (WITHIN  $\pm .06$ )  
 X DENOTES NO. OF SPACES
6. IF THE SHIM SPECIFIED IN STEP 8 IS REQUIRED, LONGER AN525-832R SCREWS MAY ALSO BE REQUIRED.
