CLASS I SERVICE INSTRUCTIONS

No. 1193
ATA Code 55-10

SUBJECT: STABILIZERS - INSPECTION OF HORIZONTAL STABILIZER ATTACH BOLTS

EFFECTIVITY: BEECHCRAFT Skipper 77, serials WA-1 through WA-7, WA-9 through WA-29, WA-31 through WA-39, WA-41 through WA-51, WA-53 through WA-70, WA-72 through WA-79, WA-81 through WA-89 and WA-91 through WA-98.

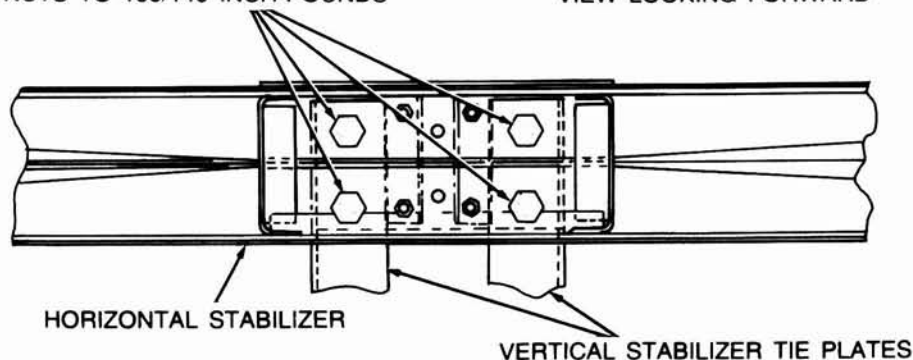
VIEW LOOKING FORWARD

NAS1105-3 /M/ BOLT
AN960-516 WASHER
(4 EA. REQ.)

TORQUE EXISTING
NUTS TO 100/140 INCH-POUNDS

4. If a bolt change is necessary or additional washers are required, refer to the illustration for correct assembly.

The correct bolts should be NAS1105-3 /M/ and should have one AN960-516 washer installed under the nut, however, NAS1105-4
