CLASS I SERVICE INSTRUCTIONS

No. 1220
ATA Code 71-00

SUBJECT: POWER PLANT - MODIFICATION OF THE CRANKCASE BREATHER TUBE

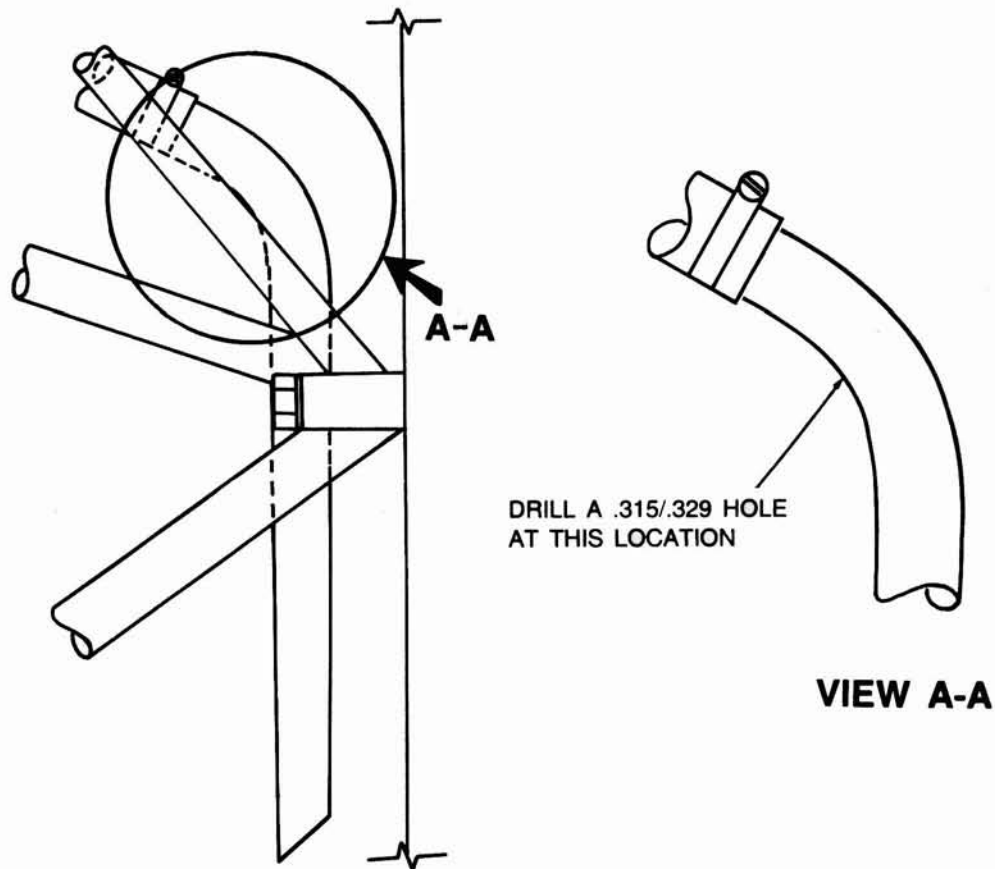
Figure 1.

REASON: To reduce the possibility of crankcase breather tube blockage.

Skipper Crankcase Breather Tube

1. Remove the engine cowling.
2. Locate the breather tube and drill a .315/.329 inch diameter hole on the inside face and at the approximate

center of the tube bend (refer to figure 1).

3. Deburr the hole and reinstall the engine cowling.

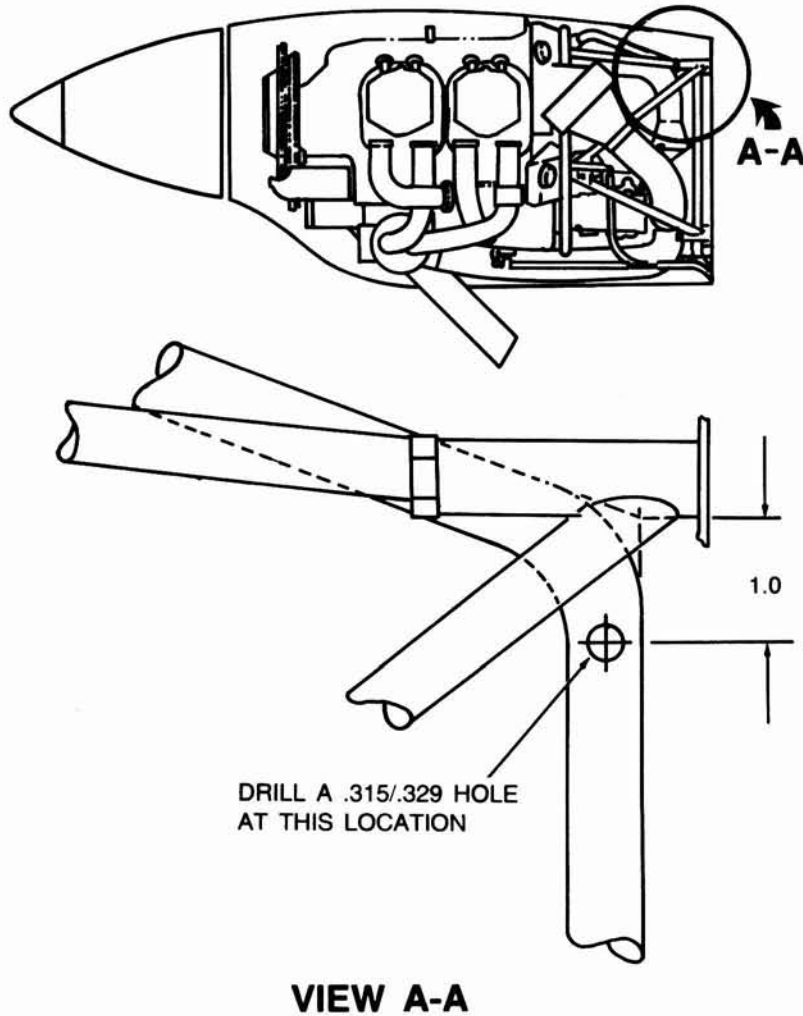
Figure 2.

Duchess Crankcase Breather Tube

1. Remove the upper engine cowling.
2. Locate the breather tube and drill a .315/.329 inch diameter hole on the left side of the tube 1.0 inch below the engine mount-to-firewall attach lug (refer to figure 2).
3. Deburr the hole and reinstall the engine cowling.
4. Repeat the procedure on the other engine.
