Beechcraft SERVICE INSTRUCTIONS

No. 1245
ATA Code 53-10
Recurring Inspection

SUBJECT: FUSELAGE - INSPECTION FOR CORROSION AT THE FIREWALL AND F.S. 68.00 FRAME.

Service Instructions No. 1245

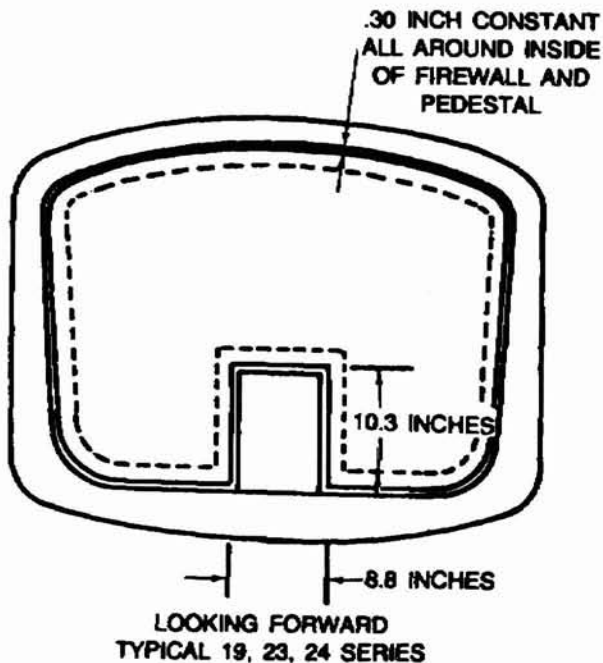
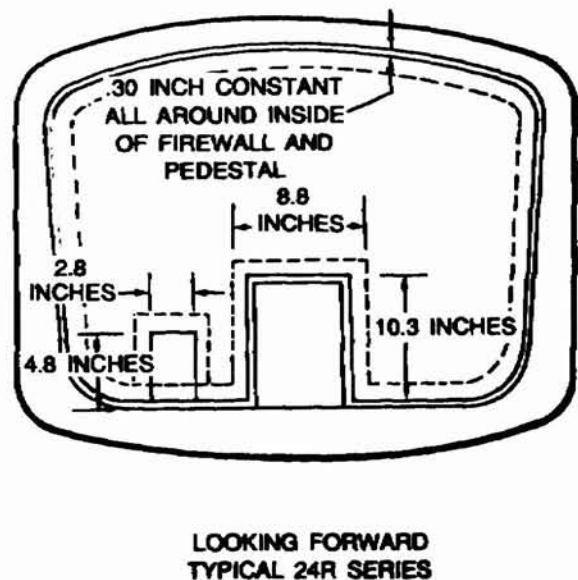
1. Refer to the Shop Manual and remove the front seats and glareshield.
2. Inspect the F.S. 68.00 (firewall) frame for corrosion, paying particular attention to any areas where the upholstery fabric on the aft side of the firewall comes in

contact with the aluminum frame (see illustration).

3. Inspect the control column center console and rudder pedal bell crank bracket inside the console by inserting a mirror into the top of the console. On fixed landing gear airplanes, pay particular attention to the forward edges of the console, where the fabric is sandwiched between the console and the firewall.

It may be necessary to lift the fabric away from the metal in order to adequately inspect for corrosion. The fabric may be reattached, using EC-1300 adhesive or equivalent (obtain locally).

4. If corrosion is found as a result of the inspection, treat and repair the corroded areas in accordance with Advisory Circulars, AC 43-4 Corrosion Control for Aircraft and AC 43.13-1A Acceptable Methods, Techniques and Practices - Aircraft Inspection and Repair. If replacement of components is necessary, accomplish in accordance with existing Beechcraft Maintenance Publications.

1. The first time the firewall is removed for any reason, trim the firewall fabric and insulation/soundproofing material so that the fabric clears the forward face of the console and the F.S. 68.00 frame by approximately .3 inch around the entire edge of the fabric.
