SERVICE INSTRUCTIONS

No. 1250
ATA Code 53-10

SUBJECT: FUSELAGE - INSTALLATION OF IMPROVED CABIN ENTRANCE STEPS.

EFFECTIVITY: BEECHCRAFT Skipper 77, serials WA-1 through WA-312.

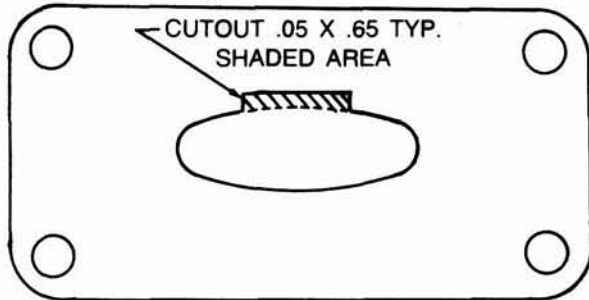
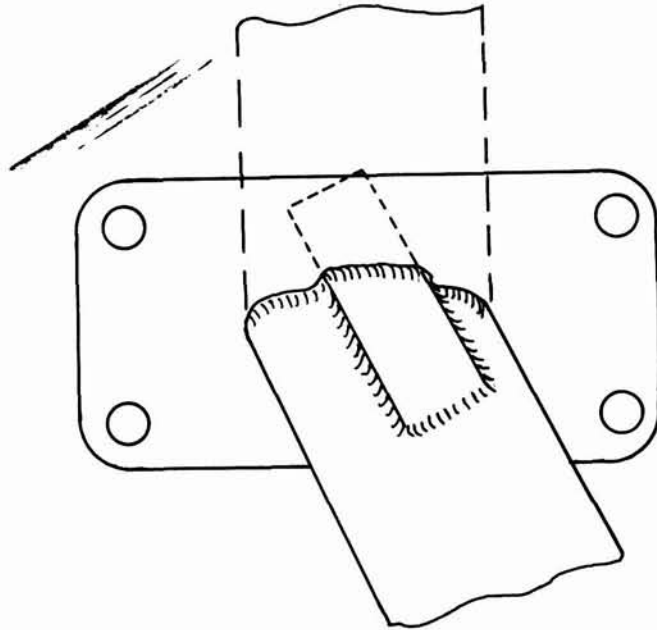
3. Insert the new assist step into the fuselage as far as possible and, using a marker, determine the amount of fuselage skin to be trimmed to facilitate installation of a new assist step. See illustrations.

4. Remove only enough material from the fuselage skin to provide adequate clearance so that, once the step is

installed, there is no evidence of chafing between the step and the fuselage. Apply zinc chromate primer (obtain locally) to the area where the fuselage material was removed.

5. Install a new assist step using the attaching hardware which was removed in Step 2.
