Beechcraft SERVICE LETTER

Model: 23

No. 3

SEAT LOCK MODIFICATION ON THE MUSKETEER

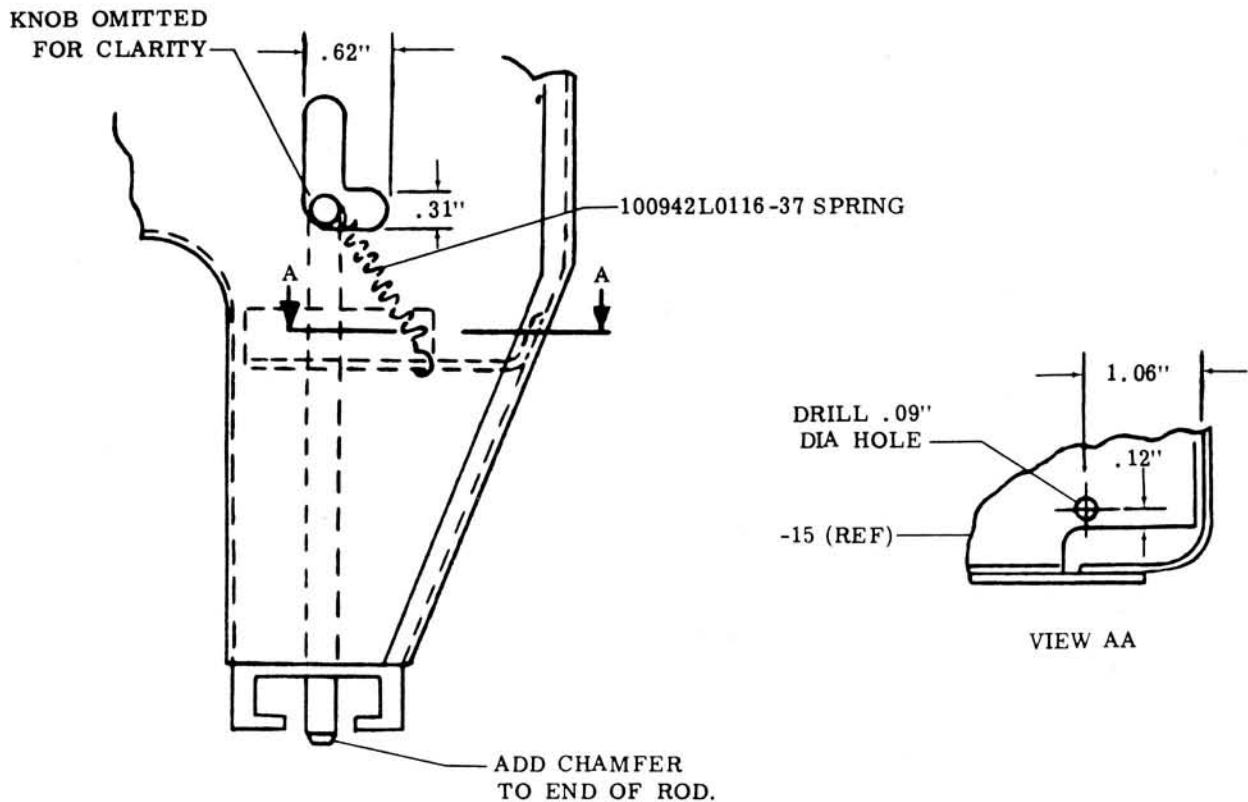
FRONT VIEW - LEFT FRONT LEG OF SEAT.

To insure more positive locking action of the front seats on the Model 23 Musketeer, the seat locking mechanism has been modified on aircraft M-192 and after. If seat locking difficulty is experienced on aircraft prior to M-192 the following modification may be made:

d. Rework the front of the seat frame, enlarging the hole as shown in the illustration.

e. Drill an .09 inch diameter hole in the 169-534012-15 bracket as shown in the illustration.

f. Replace the seat adjustment rod and attach a heavier spring, P/N 100942L0116-37, between the adjustment rod and the hole drilled through the bracket.
