Beechcraft SERVICE LETTER

No. 63-16

ADDED SUPPORT FOR ROTATING BEACON

MODELS AFFECTED: 23 prior to M-555, except M-1, M-2, M-4, M-5, M-6, M-9, M-53, M-73, M-254, M-341 thru M-347, M-433, M-468, M-482, M-483, M-504, M-505, M-508, M-511, M-515, M-516, M-519, M-521, M-523, M-524, M-526, M-532, M-533, M-534, M-536, M-538, and M-542 thru M-554.

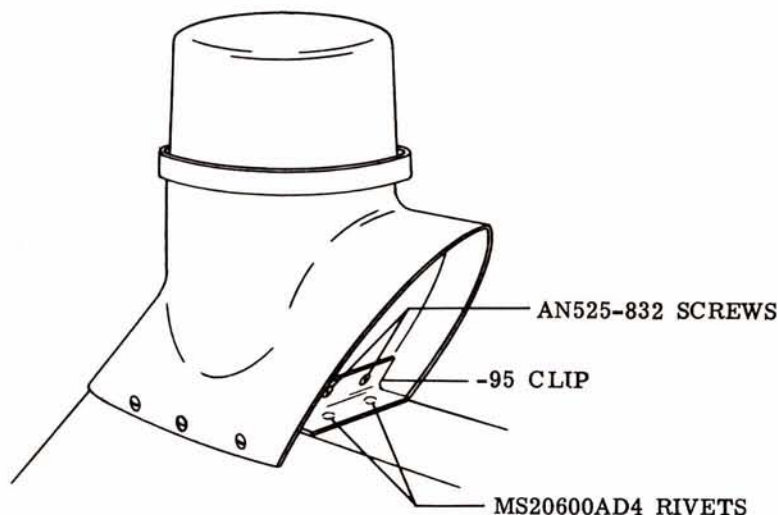
On current production Musketeers (serials M-555 and after), the tip assembly of the vertical stabilizer has been slightly modified to provide better support for the rotating beacon. The installation of a metal support clip between the rib of the vertical stabilizer tip and the cap of the vertical stabilizer strengthens the entire assembly and provides added protection against the stress exerted upon the tip by the weight of the rotating beacon. The vertical stabilizer tip on Musketeers prior to M-555 can be reinforced with similar bracing by installing 2 plate nuts on the rib of the vertical stabilizer and securing the support clip to the rib with 2 screws and to the vertical stabilizer cap with 2 rivets. The following parts are necessary for this modification:

QUANTITY	PART NUMBER	NOMENCLATURE
1	169-640000-95	Support Clip
2	130006A-832	Plate Nut
2	AN525-832-6	Screw
2	MS20600AD4	Rivet
