# Beechcraft SERVICE LETTER

No. 63-17

## LANDING GEAR TORQUE KNEE PINS REQUIRE LUBRICATION

MODELS AFFECTED: All Model 23

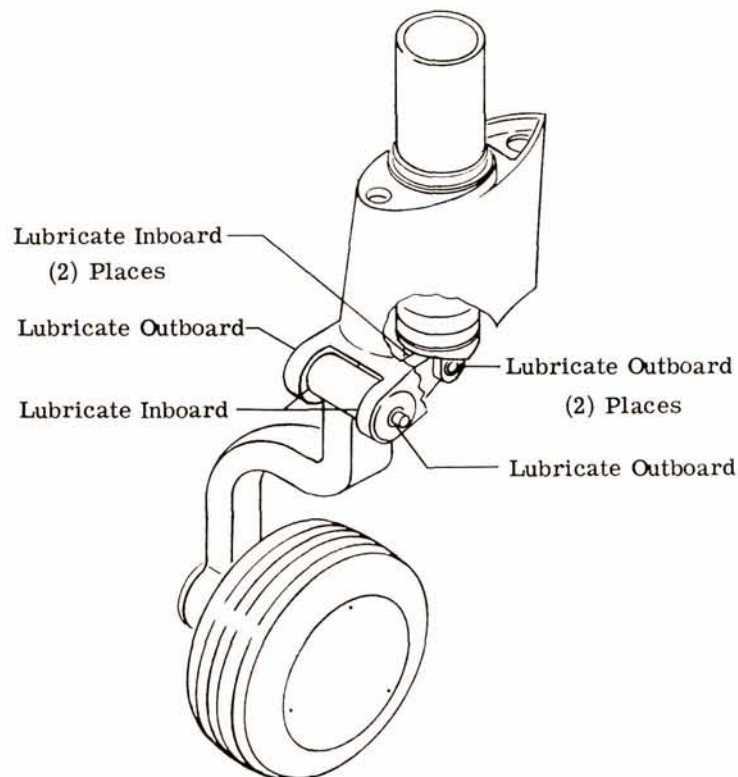
Reports from the field indicated that some Musketeer owners have experienced seizure of the torque knee pins in the bushings of the Main and Nose landing gear struts. Because the oilite bushings may have lost some of their lubrication properties, the bushings and pins should be lubricated with #30 weight engine oil. (See illustration.)

Upon receipt of this letter, it is recommended that Musketeers with 25 hours or more of operation be lubricated at the torque knee pins and bushings of the Nose and Main landing gear struts. Lubricate the pins and bushings at every 25 hours of operation thereafter.
