Beechcraft SERVICE LETTER

No. 64-32

CHECKING THE ATTACH BOLTS OF THE VERTICAL STABILIZER ON MUSKETEERS FOR TORQUE

MODELS AFFECTED: All 23 airplanes.

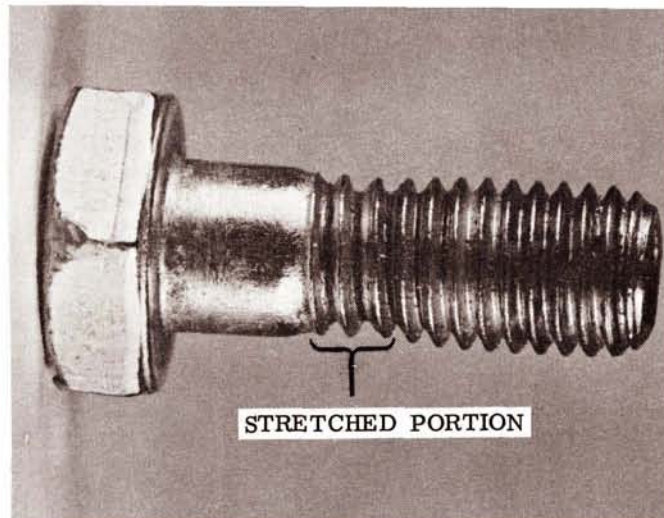
There have been instances in the field where the bolts attaching the front and rear spars of the vertical stabilizer to the fuselage were found to be stretched. Such a condition will occur only if too much torque has been applied to the affected bolts. This letter is a reminder to owners and maintenance personnel that the proper torque of these bolts is 50 to 70 inch-pounds. It is further recommended that these attach bolts be checked for proper torque at the next scheduled 100-hour inspection. This can be done by removing each bolt individually and visually checking it for indications of stretching. Damaged bolts should be replaced and each bolt that was removed should be reinstalled at the proper torque of 50 to 70 inch-pounds.
