Beechcraft SERVICE LETTER

No. 66-5

KIT 23-9001

AFT COWL REINFORCEMENT

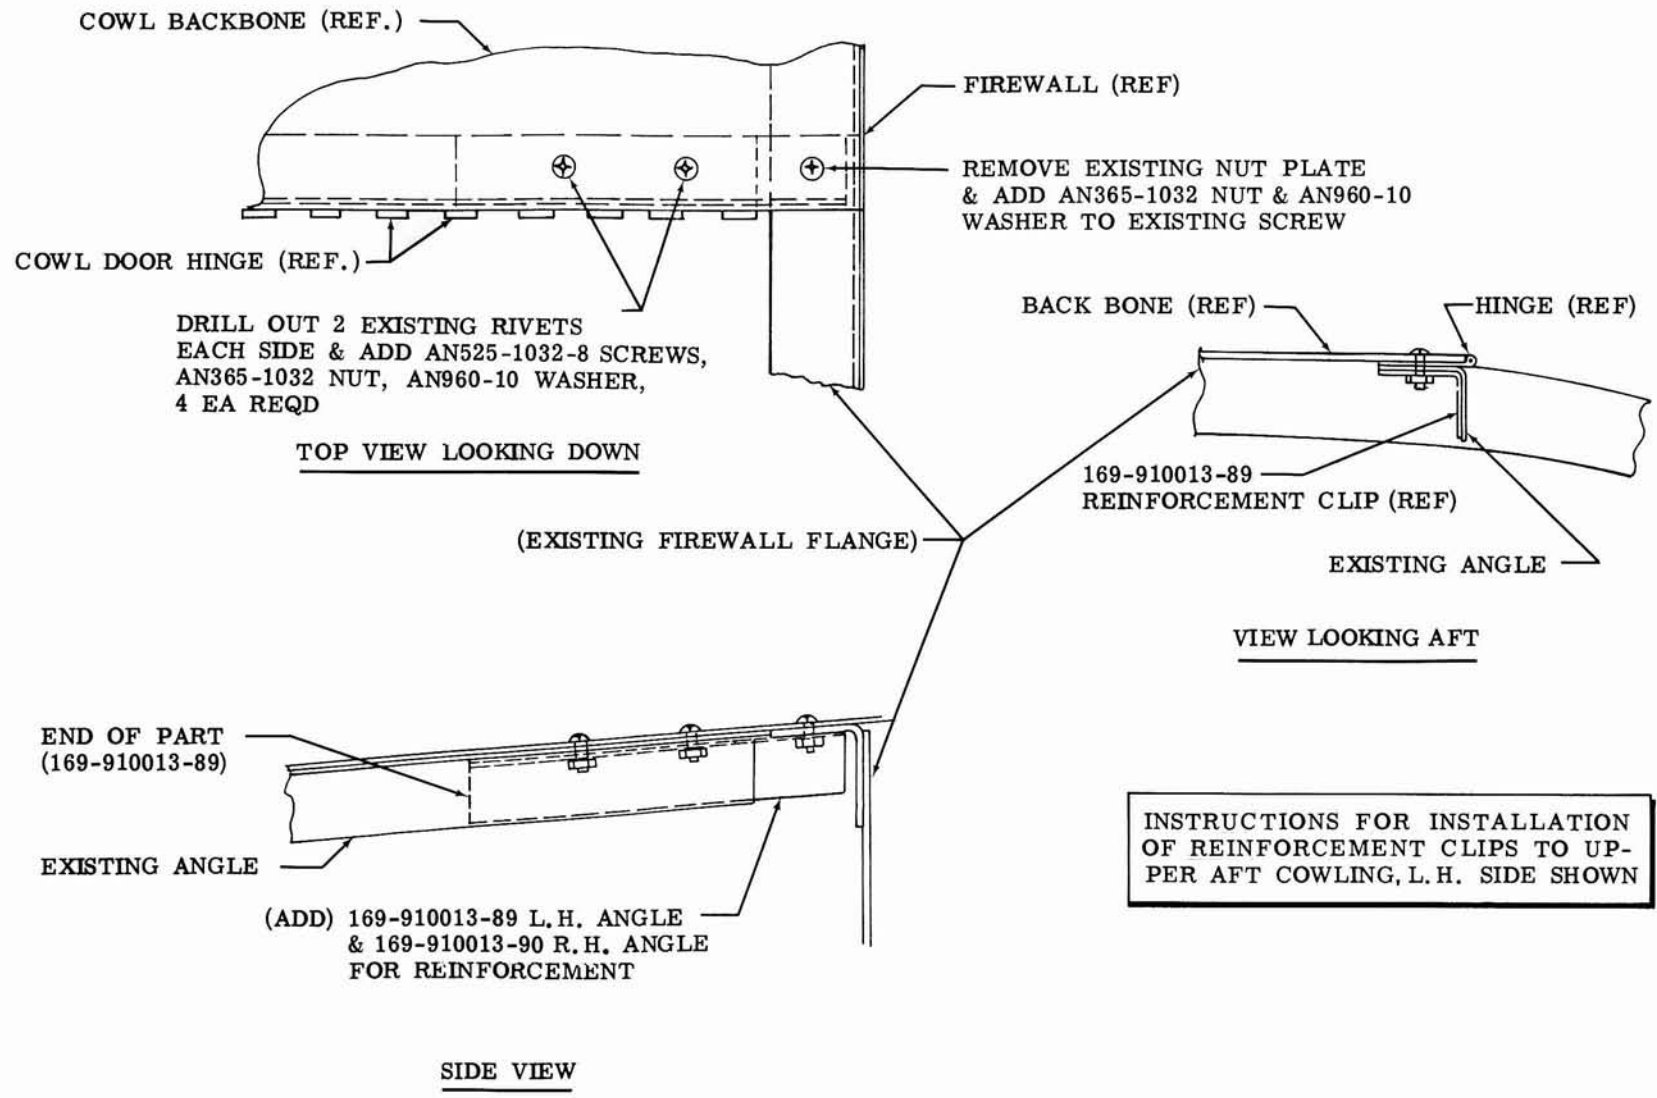
Service experience reveals that addition of two reinforcement clips to the top aft cowling are desirable for stiffening the backbone and improving the reliability of the cowling. The clips may be installed as shown in the illustration (See reverse side).

Kit 23-9001 contains a packing sheet on which the parts for this retrofit are listed. It is suggested that this packing sheet be retained on file until such time as the listing of parts is included in the Parts Catalog.
