No. 67-19

Rev. I

SUBJECT: A NEW THROTTLE CONTROL FOR THE BEECHCRAFT MUSKETEER

AIRCRAFT AFFECTED: All BEECHCRAFT Model 23, A23 and A23A aircraft, serials prior to M-1069; all Model A23-19, serials prior to MB-265; all Model A23-24, serials prior to MA-273.

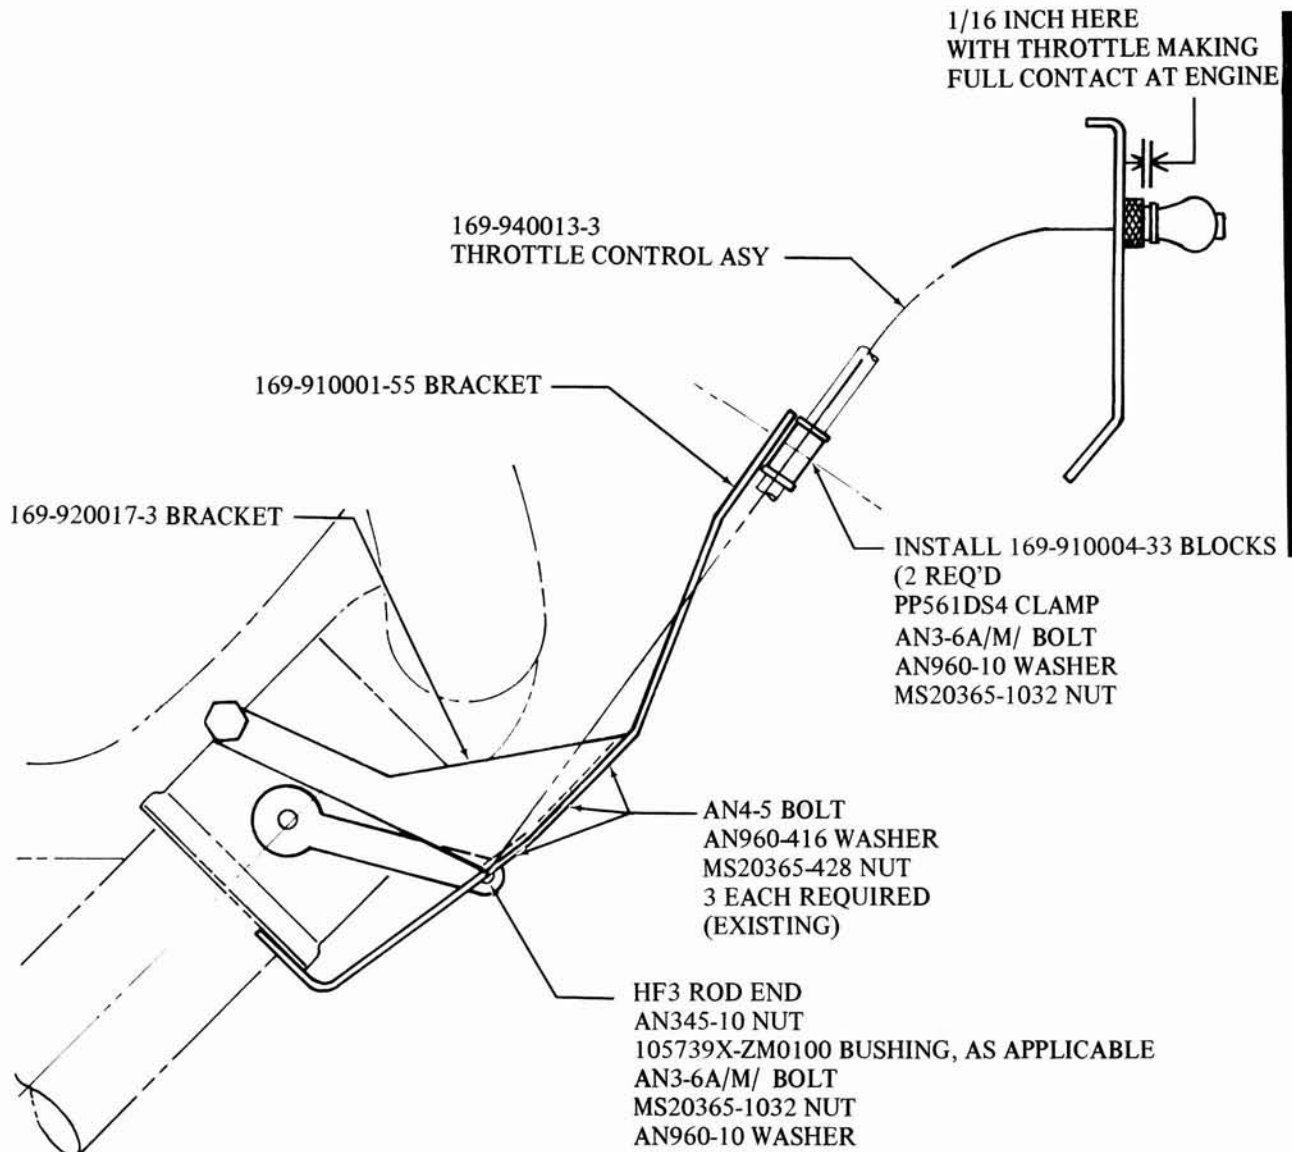
FIGURE I

MODEL A23 AND A23A

8. Tie or clamp the control as required to prevent abrasion with other components. Adjust the control cable so that when the control is making full throttle contact at the throttle body, a gap of 1/16 inch remains between the knurled nut and the stop nut at the instrument panel. (See

figure 1 for an illustration of the properly rigged throttle control assembly installed in Part I.)

12. Tie or clamp the control as required to prevent abrasion with other components. Adjust the control cable so that, when the control is making full throttle contact at the throttle body, a gap of 1/16 inch remains between the knurled nut and the stop nut at the instrument panel. (See figure 1 for an illustration of the properly rigged throttle control assembly installed in Part II.)

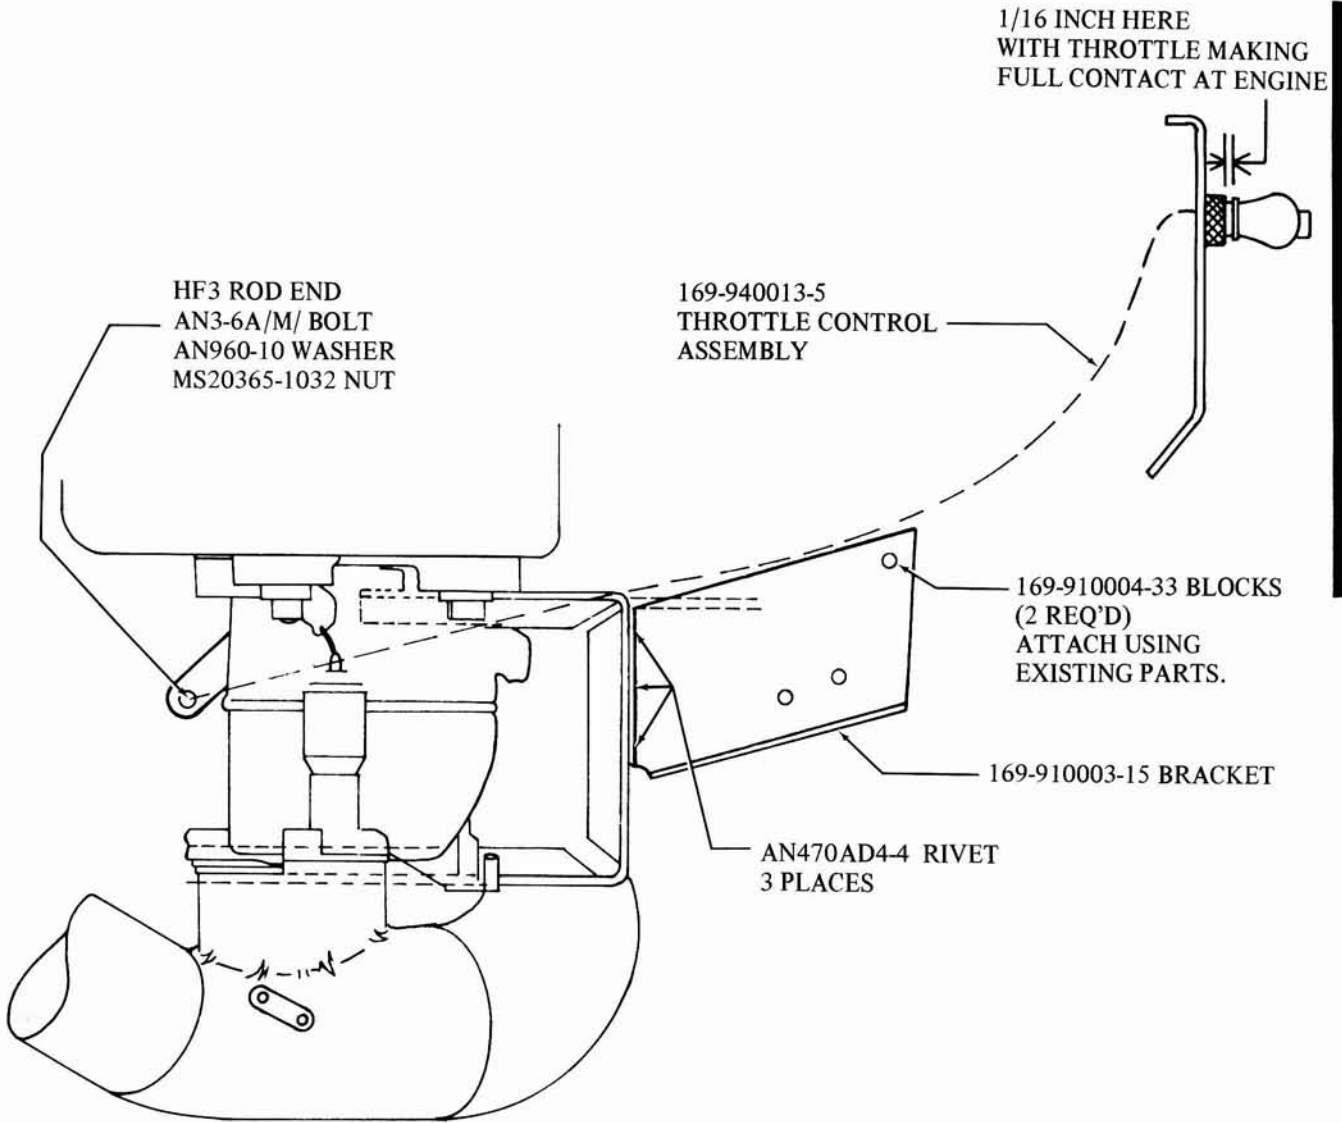
FIGURE 2

MODEL 23 AND A23-19 AIRCRAFT

7. Adjust the control cable so that, when the control is making full throttle contact at the throttle body, a gap of 1/16 inch remains between the knurled nut and the stop nut at the instrument panel. (See figure 2 for an illustration of the properly rigged throttle control assembly installed in Part III.)

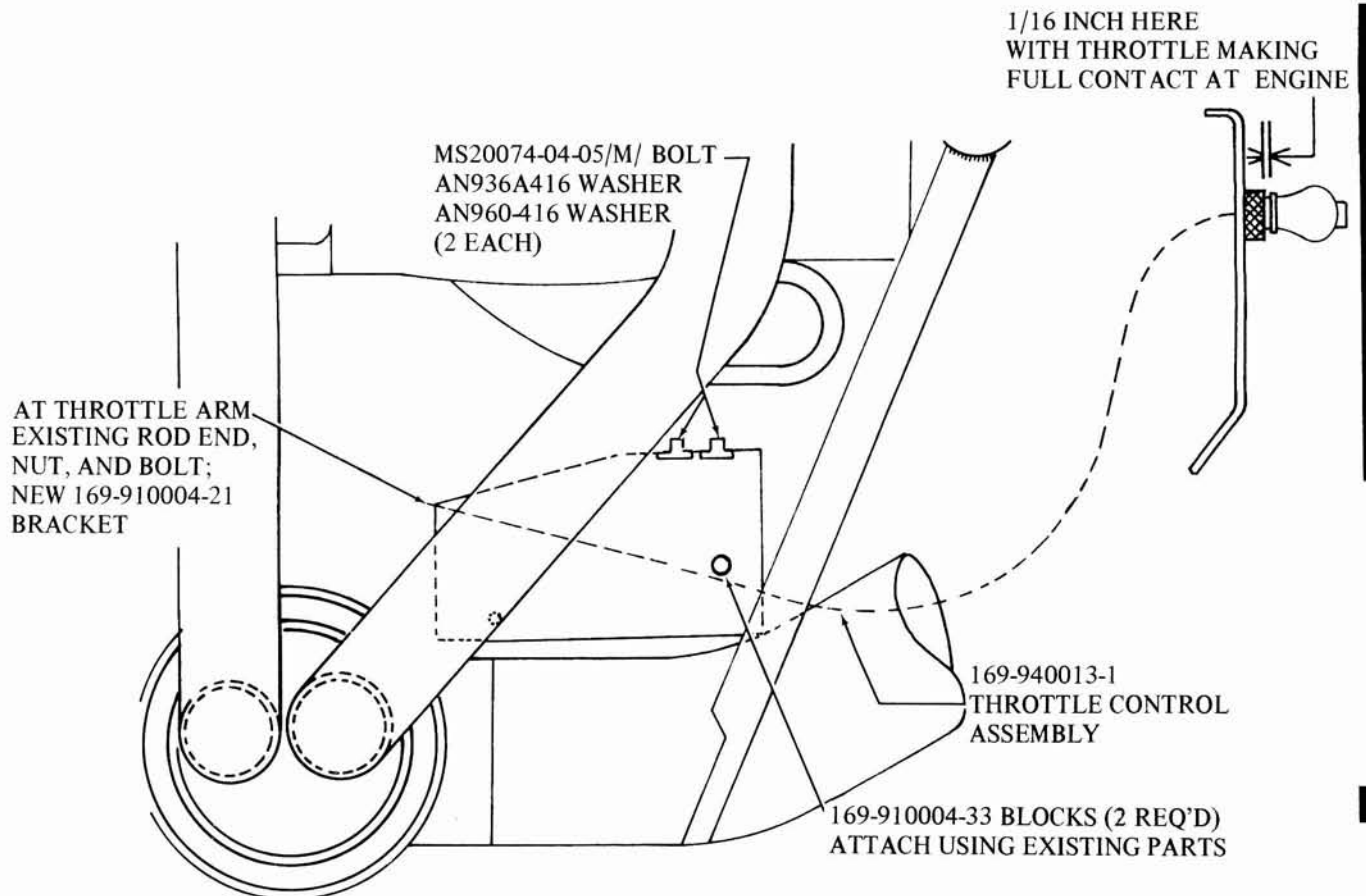
FIGURE 3

MODEL A23-24
(VIEW LOOKING INBOARD FROM LEFT SIDE)

6. Adjust the control cable so that, when the control is making full throttle contact at the throttle body, a gap of 1/16 inch remains between the knurled nut and the stop nut at the instrument panel. (See figure 3 for an illustration of the properly rigged throttle control assembly installed in Part IV.)
