# SERVICE INSTRUCTIONS

No. 0042-031, Rev. II  
ATA Code 53-40  
Recurring Inspection

**SUBJECT:** FUSELAGE - INSPECTION OF FORWARD WING ATTACH POINT

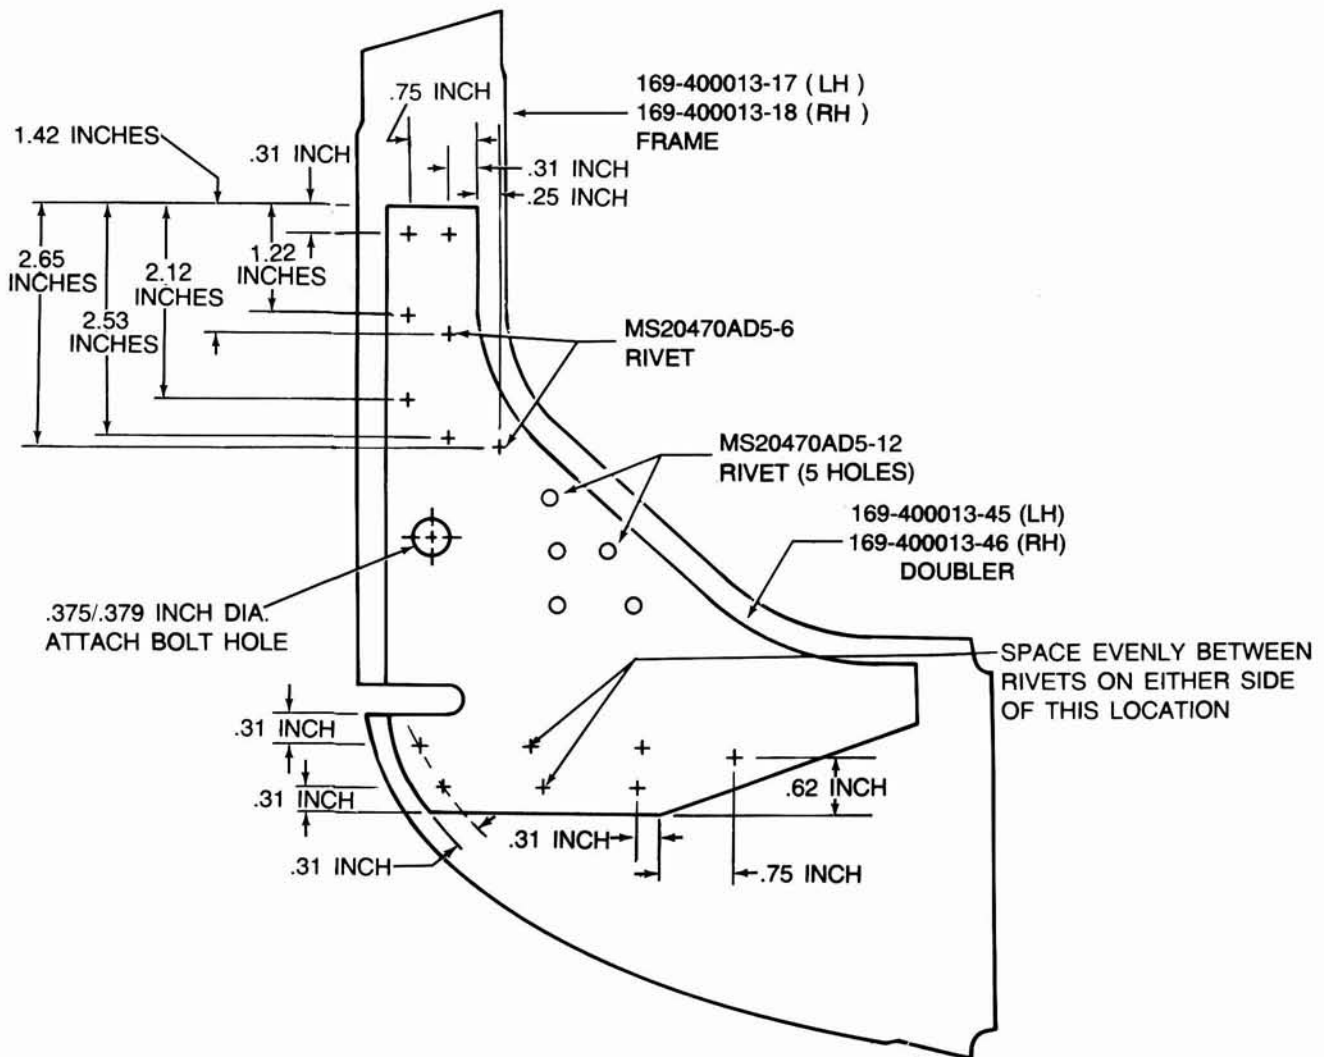
Figure 3.

- d. If the gap exceeds  $.320 \pm .010$  inch, back the wing attach bolt out just far enough to install P/N AN960-616 and/or AN960-616L washers as required to fill any gap between the lug on the wing and the bracket or frame. If a P/N AN960-616 washer is not installed under the head of the bolt, the bolt must be removed.

- e. Ensure a P/N AN960-616 washer is installed under the head of the wing attach bolt and install the bolt. Install a P/N 100951DD063YN washer on the bolt next to the bracket, then a P/N AN960-616 washer, and install an MS20365-624A nut. Torque the nut to 100/120 inch-pounds and reinstall the side panels, carpets and seats.
