**AILERON-RUDDER INTERCONNECT SYSTEM:  
PART I, MODIFYING BUNGEE CLEVIS ENDS  
PART II, RIGGING BUNGEE CABLES AND SPRINGS**

**MODELS AFFECTED:** 23 (Prior to M-471)

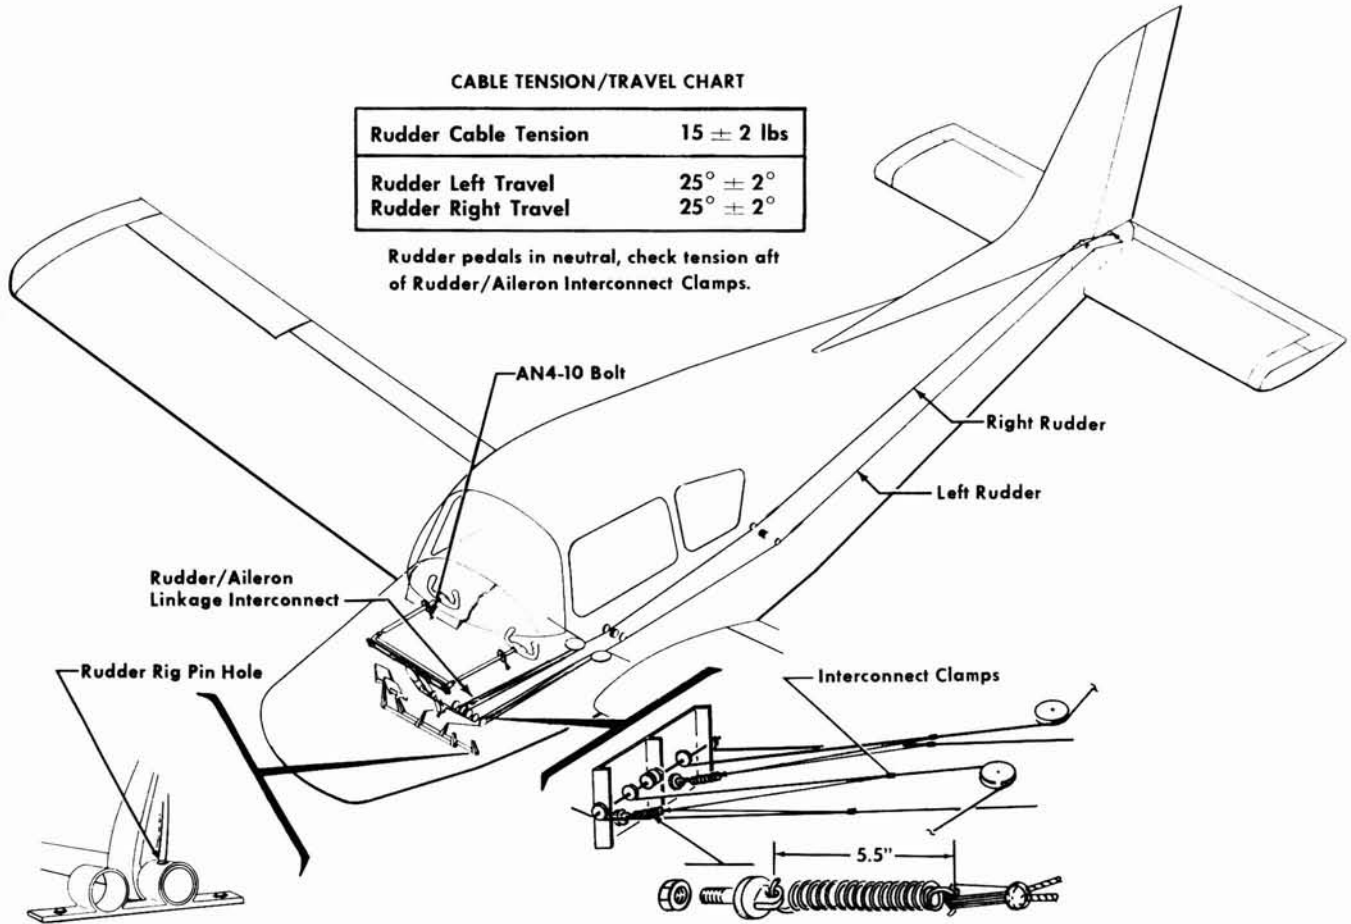
7. Taking care to avoid moving the tab assembly, loosen the center floorboard forward and aft of the tab handle in order to gain access to the bungee cables and spring of the interconnect system.
